Major Refurbishment
Turns Back Time on
Monash Uni's 'Ming Wing'

Concrete Repair

Robert Menzies Building
Refurbishment

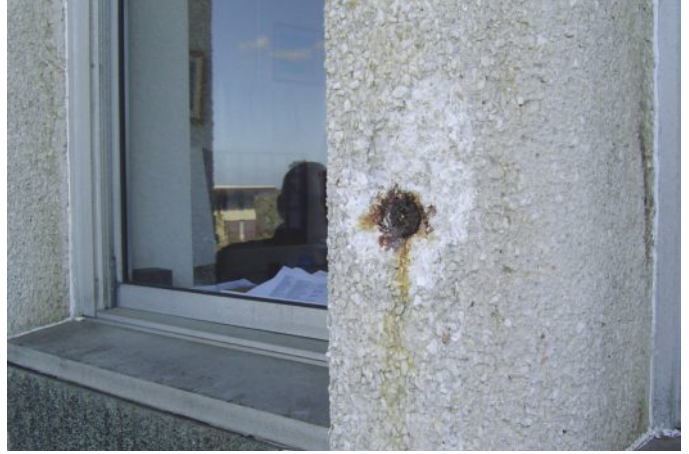
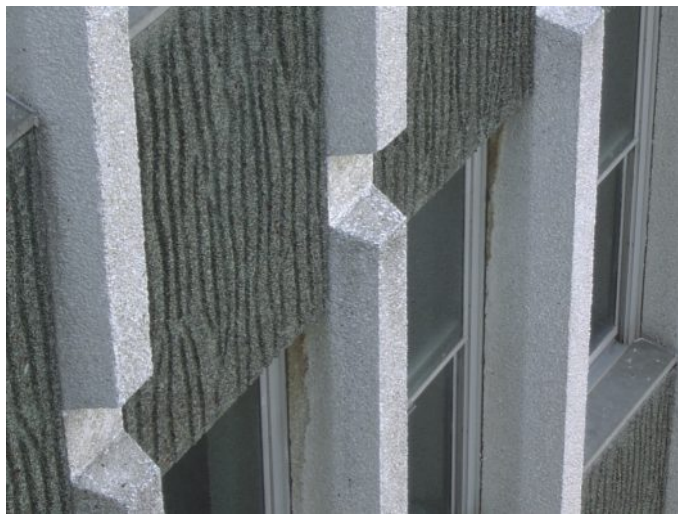
The building's façade was suffering from chloride attack and as a result there was a significant amount of damage to the spandrel panels – both in terms of spalling, and delamination of the green surface layer. In addition, a number of the longitudinal mullions were also showing signs of deterioration and damage caused by corrosion of the cast-in-place lifting ferrules.

Once the loose concrete was removed from the damaged sections, the exposed reinforcing steel was coated with **Barrafer® A**, a passivating primer that provides permanent protection for reinforcing steel against corrosion. Depending on the extent and/or type of damage, the damaged areas were then repaired using either **Barra® Mortar HL with MCI** (a cementitious, trowel-applied, lightweight polymer modified repair mortar for high build applications) or **Emaco® S88C with MCI**, a cementitious, trowel-applied, shrinkage compensated structural repair mortar. Both repair mortars also contained an added Migrating Corrosion Inhibitor to further protect against corrosion.

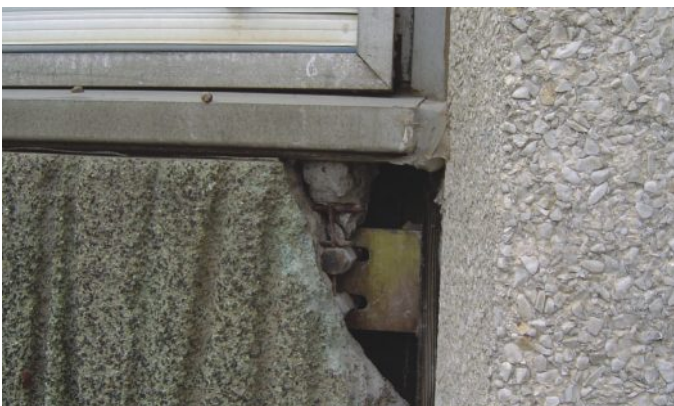
- Repairing the damaged spandrel panels and mullions
- Protecting the façade to minimise further damage
- Matching the building façade's original dark green colour
- Enduring that the majority of the building remained 'fully operational' during the repair and protection works

With the physical repairs complete, the precast spandrel panels were sprayed with a coating of **Protectosil CIT**, a silane-based hydrophobic impregnant with an integrated corrosion inhibitor. Sprayed directly onto the surface of steel reinforced concrete structures, **Protectosil CIT** combines a penetrative silane treatment for the control of moisture and chloride ion ingress with advanced organofunctional corrosion inhibition in a single product, thereby significantly reducing application costs.

The final phase of the repair works involved the application of BASF's **Masterseal® 160D** to the façade's spandrel panels. Specifically developed to provide protection for concrete, mortar, masonry, natural stone or wood against aggressive environmental attack from carbon dioxide and chloride ions, **Masterseal® 160D** delivers the ideal combination of protection and aesthetics. In keeping with the heritage order requirements for the Robert Menzies Building refurbishment, the **Masterseal® 160D** used on the project has been colour-matched to the building façade's original dark green colour.
